CASE STUDY

Fuelling Machine Repairs

**CANADIAN METAL-AD
CORPORATION**

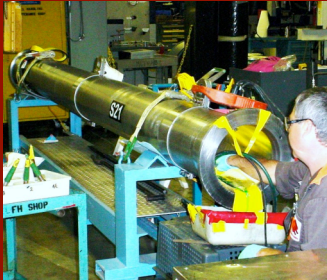
Score damage on I.D. of the RAM barrel housing being repaired with Brush Nickel Plating

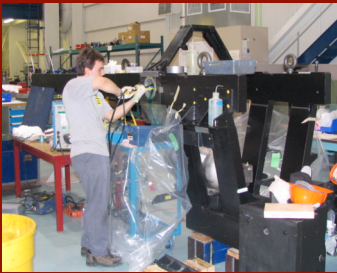
Brush Plating repair done on an oversized bearing fit on the FM frame unit.

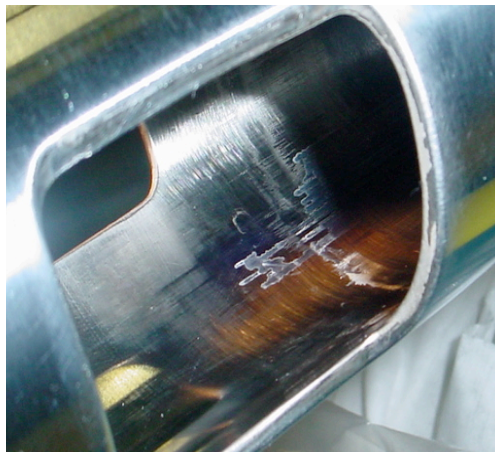
**PITTING DAMAGE ON THE I.D. OF LATCH TUBE
CAUSE HIGH LEAK RATES AT THE CLEVITE SEAL**

Among the many uses CMC has found for the Brush Plating process in the nuclear industry, Fuelling Machine, and in particular RAM tube refurbishment, has become one of the most successful repair programs to date. As shown above this Latch tube has sustained scoring, pitting and erosion damage at the clevite seal area. Using specifically designed plating and turning equipment; damages of this nature are permanently repaired in a few of days. This represents a huge savings when compared to the replacement cost of a new set of tubes. The program has been so successful that Pickering OPG has now included this Brush Plating repair procedure as routine on every RAM overhaul.

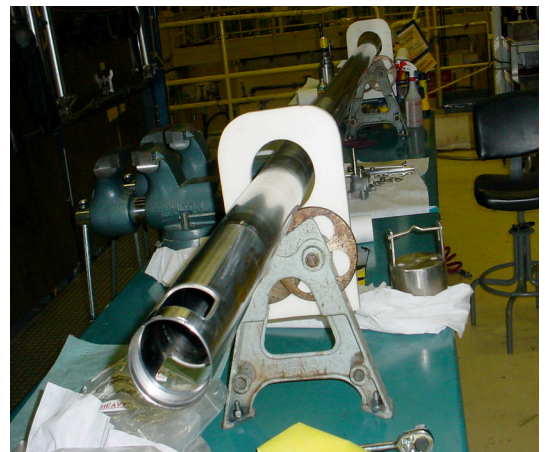
**UNIQUE SET UPS HAVE BEEN DEVELOPED FOR
THE REPAIRS ON ALL TYPES OF RAM TUBES**
